# **FLOOD PLAIN INFORMATION**

## **GREAT FALLS, MONTANA VOLUME II**

### **MISSOURI RIVER**

PREPARED FOR  
CITY OF GREAT FALLS  
COUNTY OF CASCADE STATE OF MONTANA  
BY  
DEPARTMENT OF THE ARMY, OMAHA DISTRICT, CORPS OF ENGINEERS, 68102  
JUNE 1974

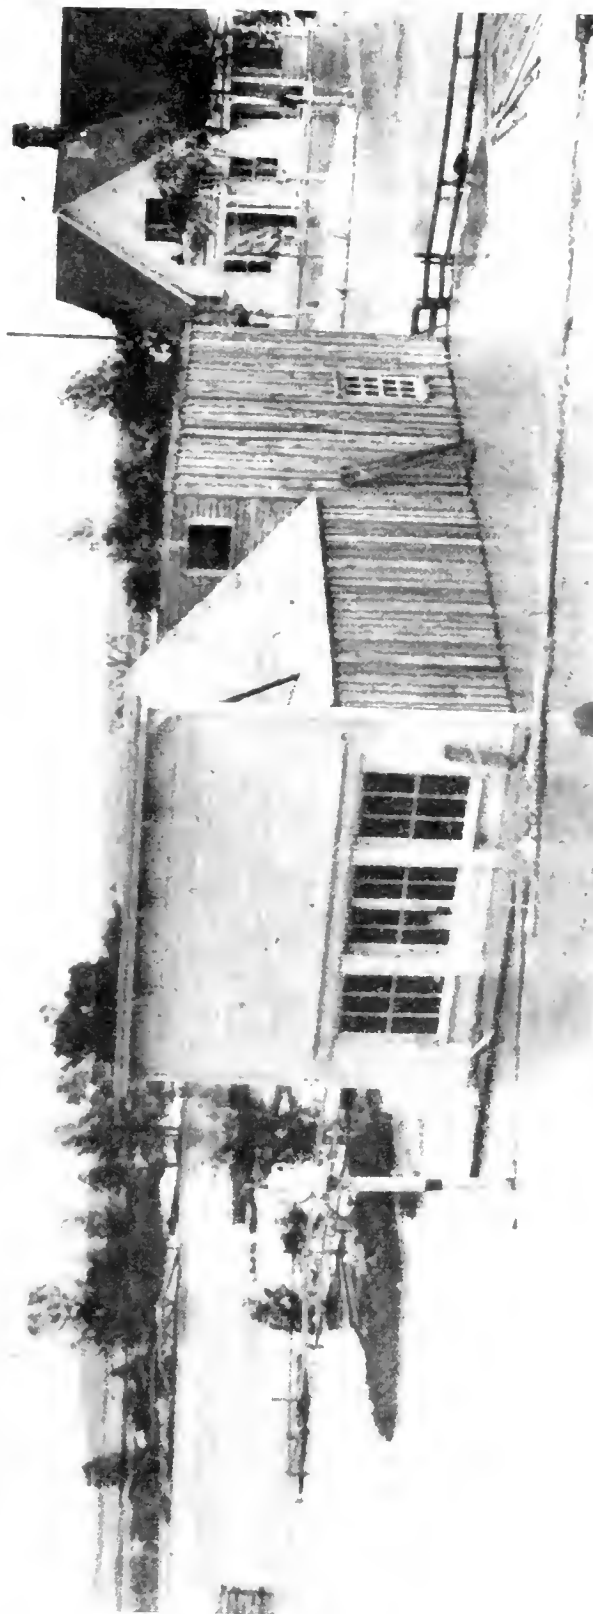
Figure 5. 7 June 1993, John Largent building, water at floor level.  
1916 flood was 3 inches higher.

A photograph of a part of Great Falls during the flood is reproduced as figure 5.

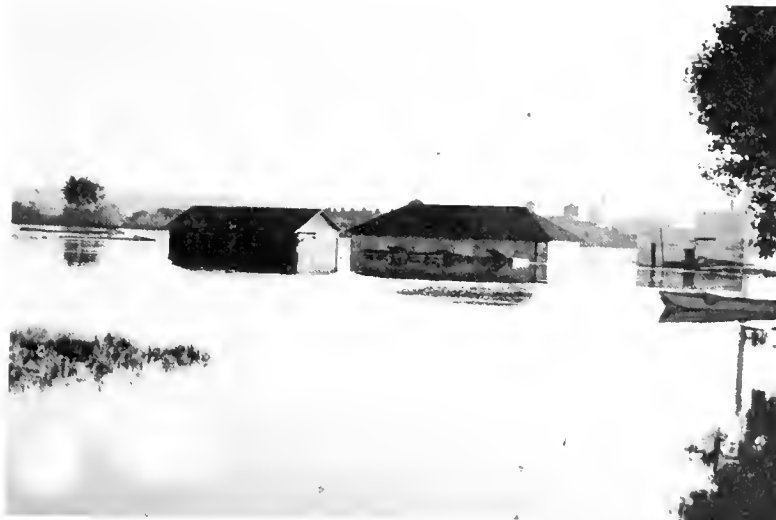
Figure 7. 7 June 1948, view looking west from east bank of Missouri River. Flooding of Great Falls Boat Club buildings.

Photographs of the June 1948 flood on the Missouri River at Great Falls are reproduced as figures 6 through 9.

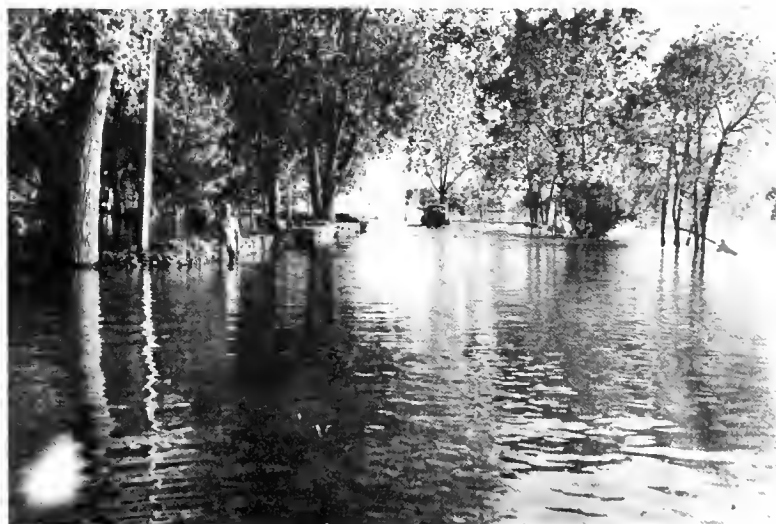
Figure 8. 7 June 1948, view of flooding of county road and park area near waterworks plant.

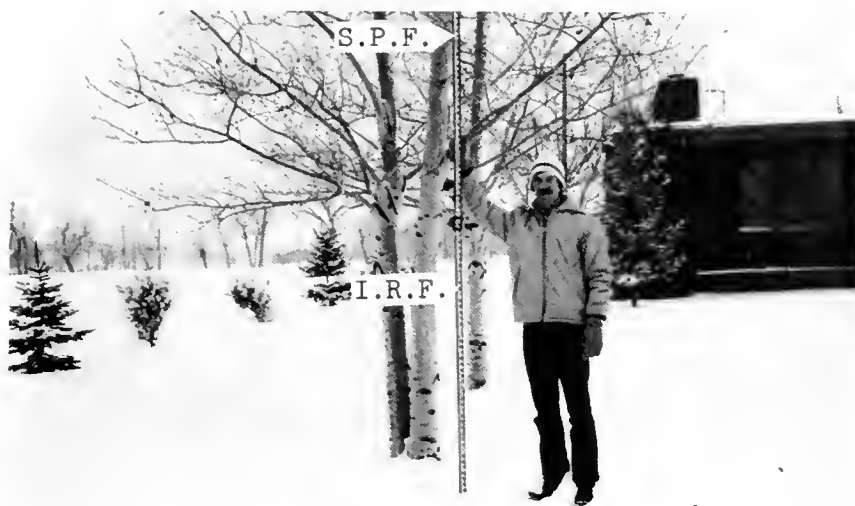
Figure 10. Potential flood depths, at east end of Meadowlark Drive.

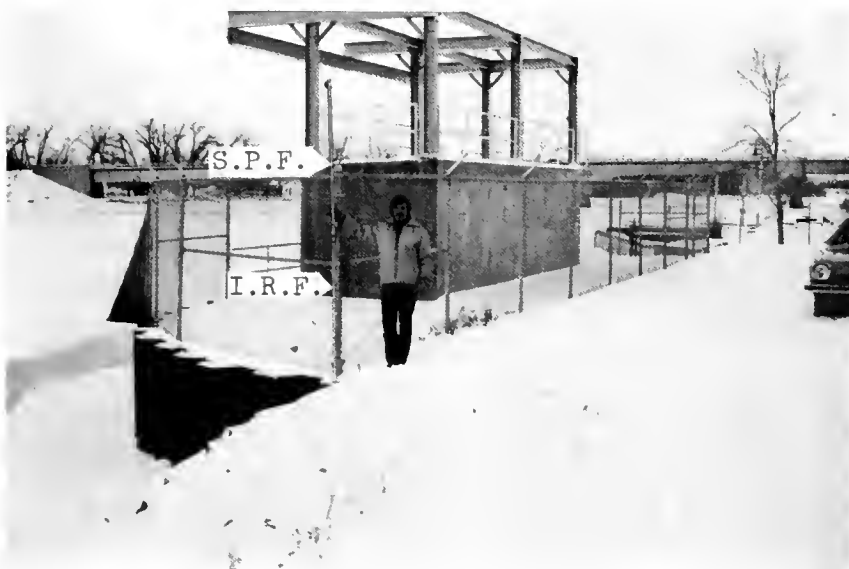
Figure 11. Potential flood depths, on right bank, at city water intake.

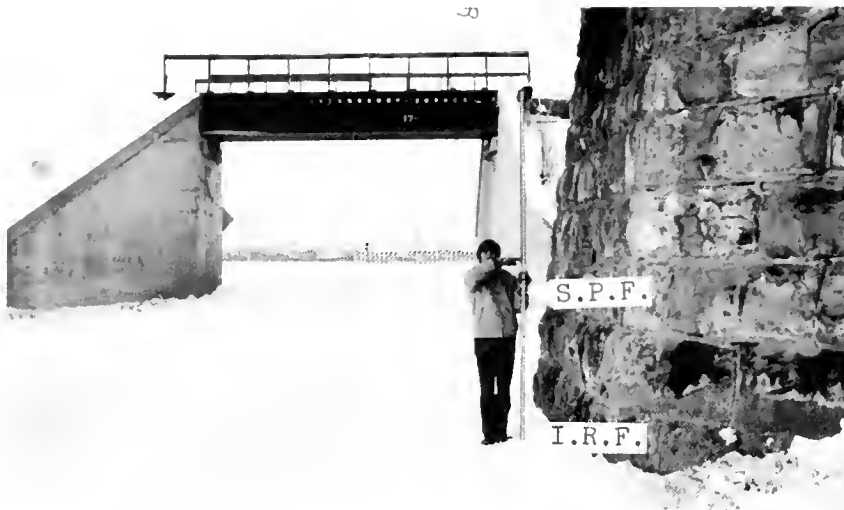
Figure 12. Potential flood depths at Great Northern Underpass. Level hand indicates the high water elevation of the 1903 flood.

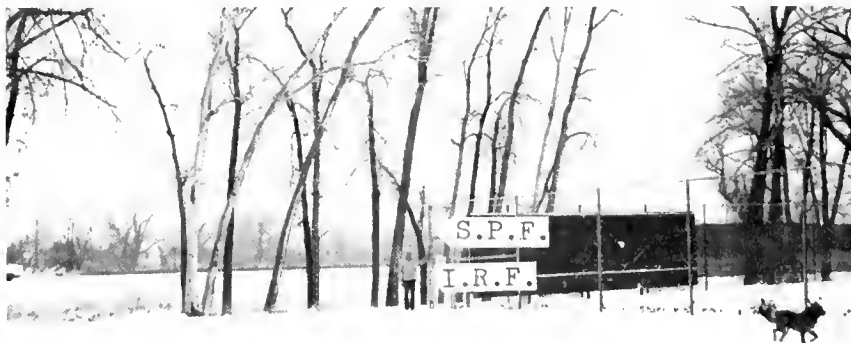
Figure 13. Potential flood depths, on left bank, at Meadowlark Country Club tennis courts.

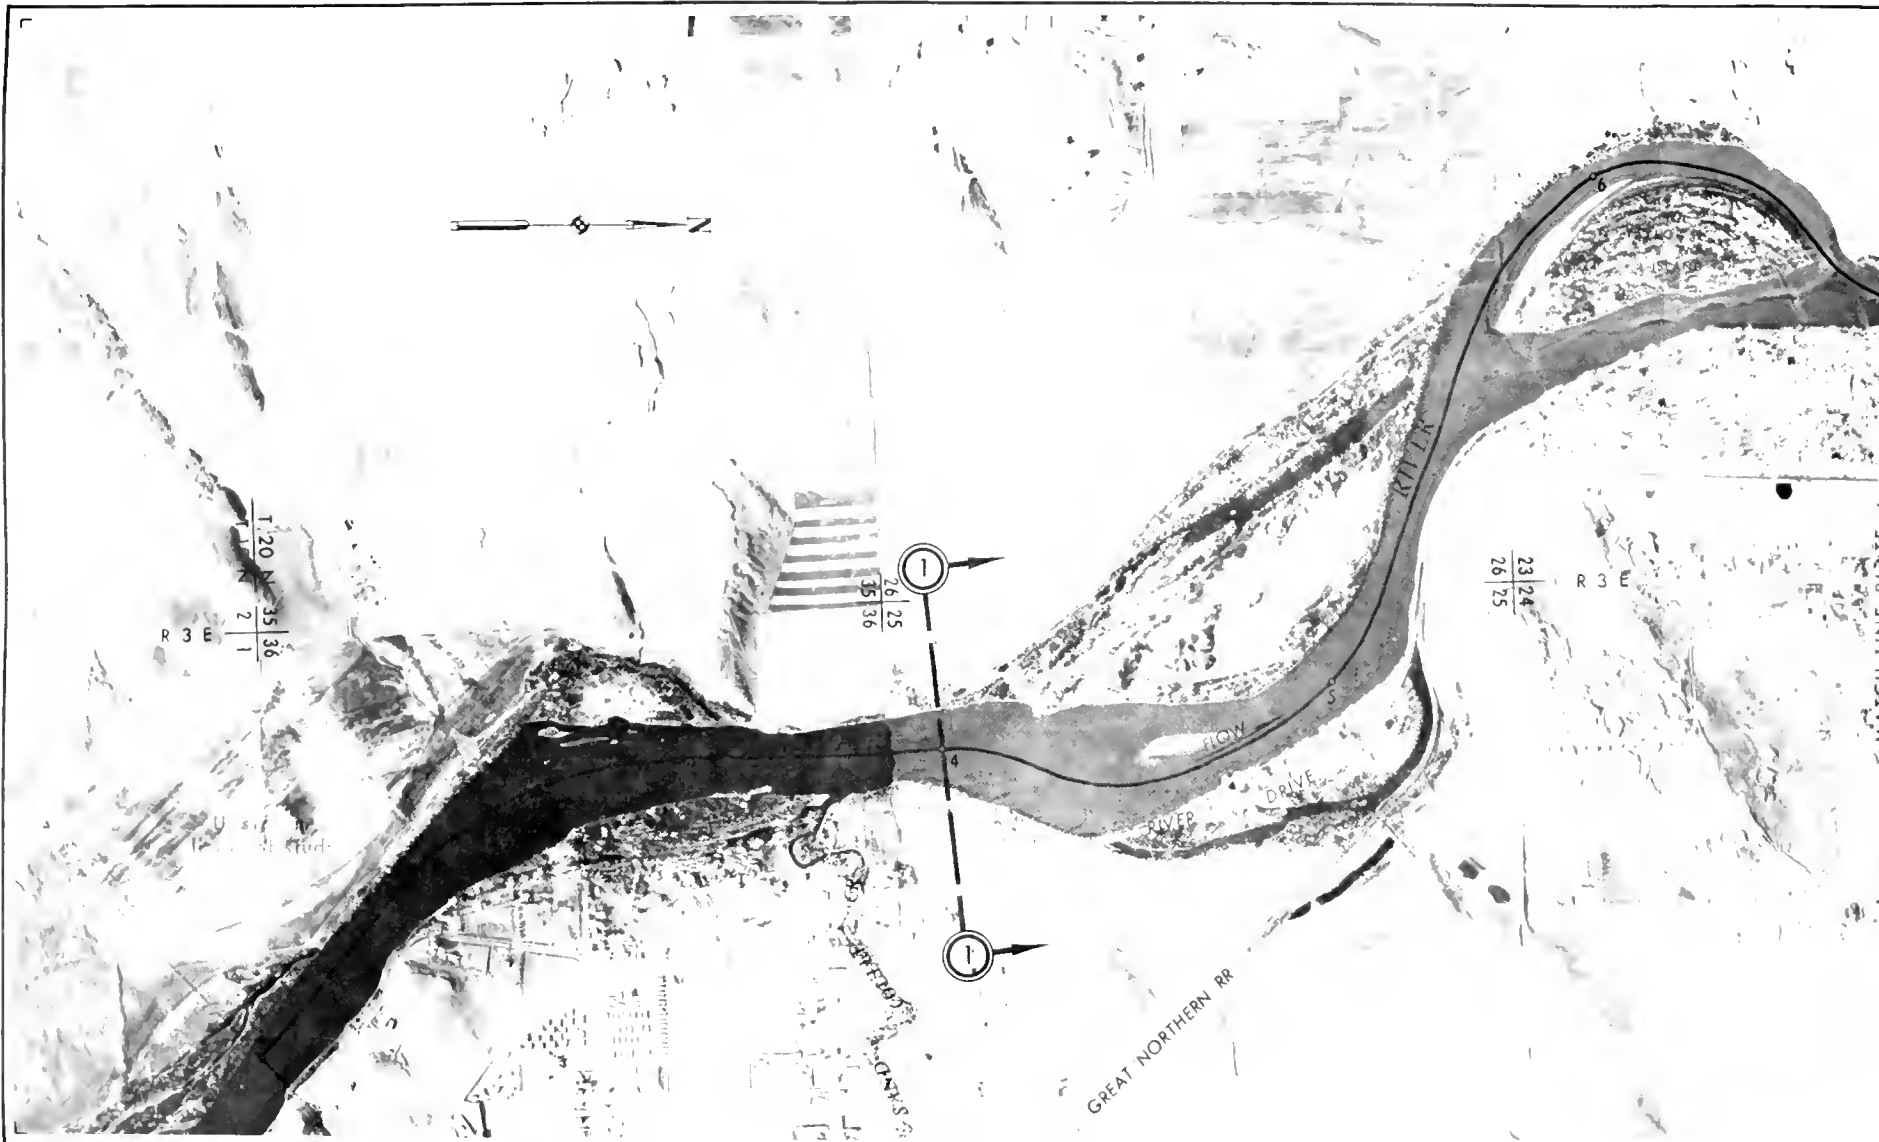
MISSOURI RIVER BASIN  
\*GREAT FALLS, MONTANA  
MISSOURI RIVER  
PLATE INDEX MAP  
U. S. ARMY ENGINEER DISTRICT, OMAHA  
CORPS OF ENGINEERS OMAHA, NEBRASKA  
JUNE 1974
